Portage Creek Sediment Remediation Project Kalamazoo, Michigan

Post-Sediment Removal Structure Feature Assessment Removal Area SA6

F&V Project Number: 809930
August, 2012

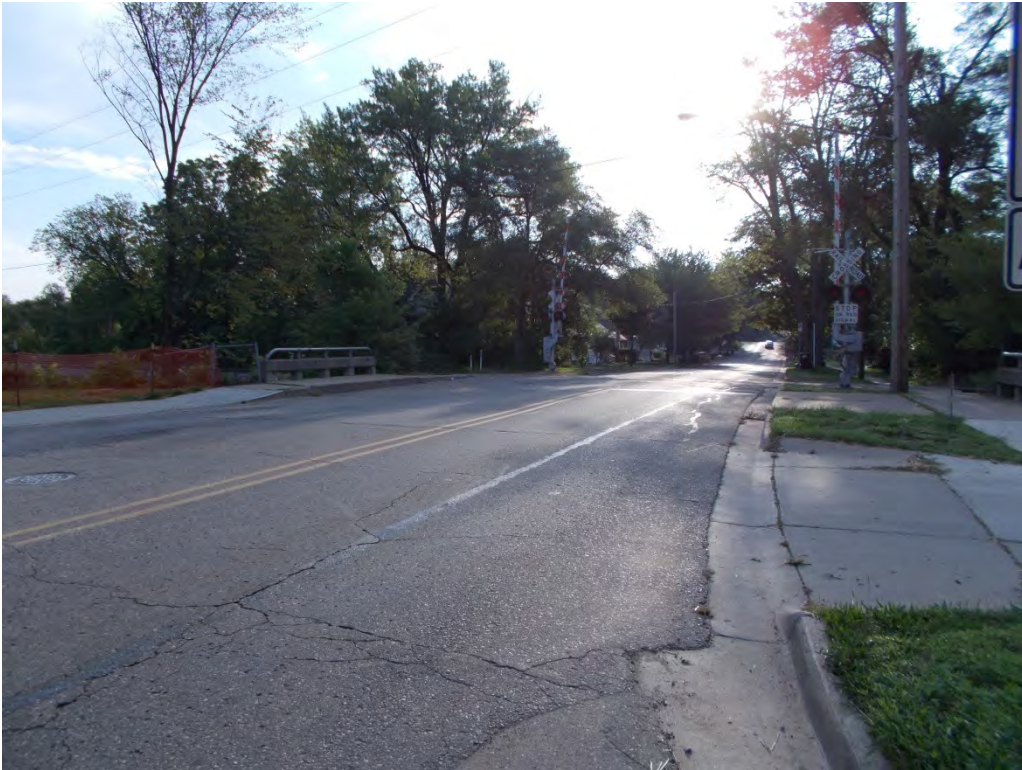
Structure viewed from southwest approach area

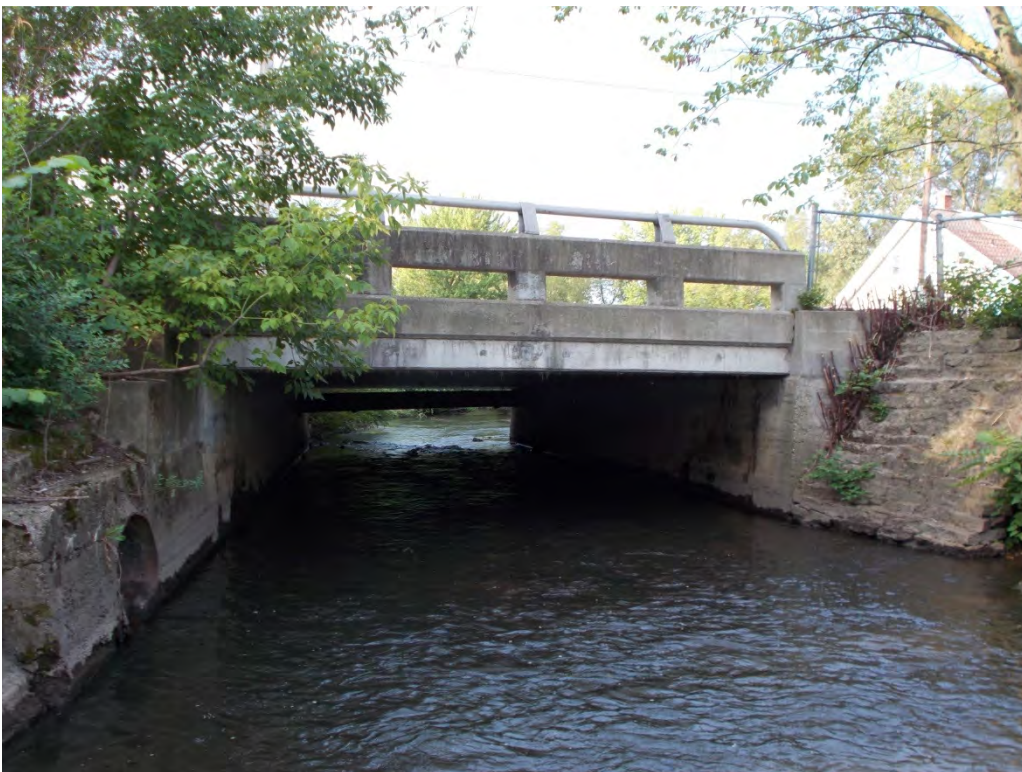
Elevation view of structure

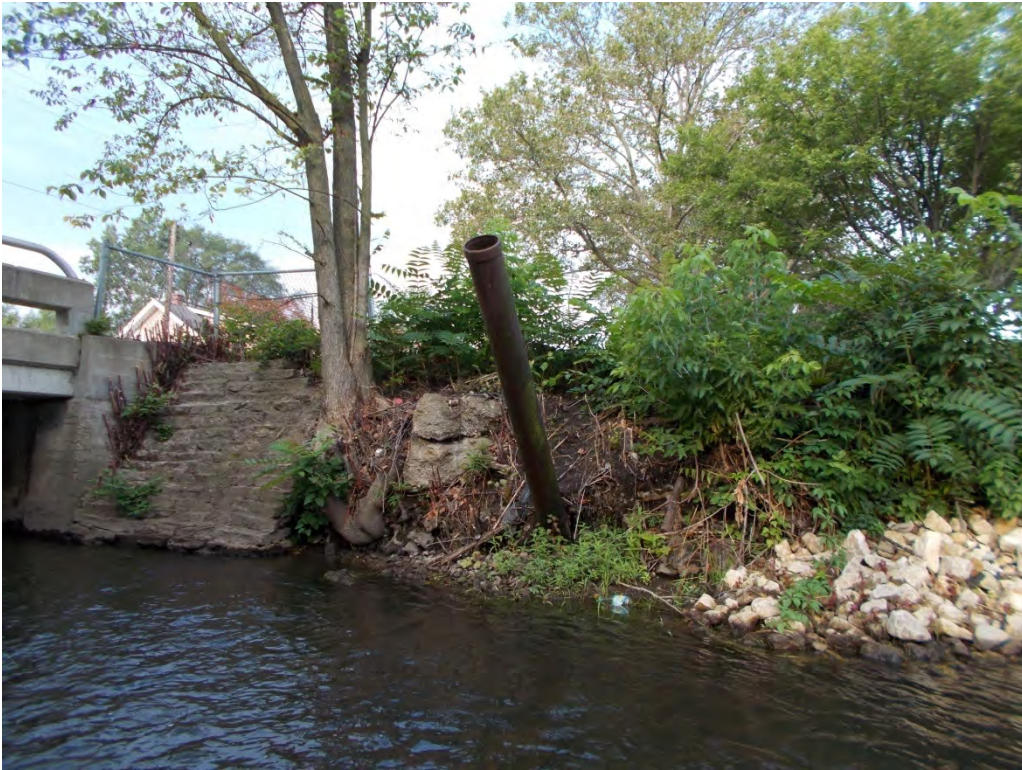
- The structure does not appear to have been impacted during sediment removal.

Overall view of the structure from the channel

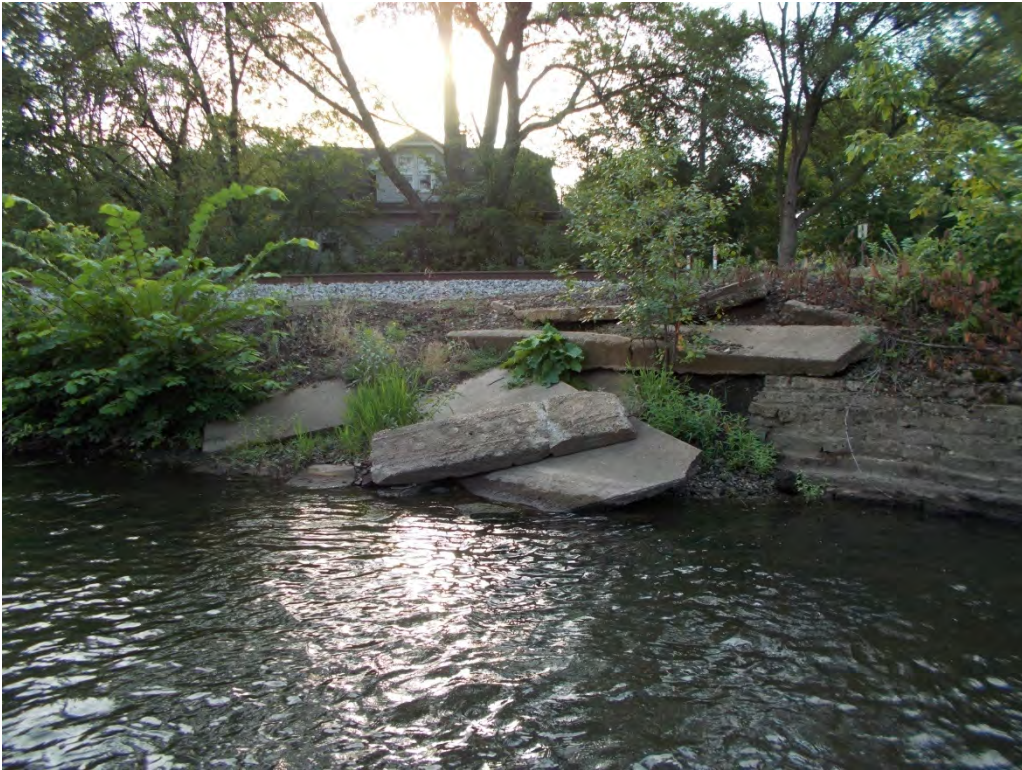
- The structure does not appear to have been impacted during sediment removal.

Overall view of the structure with the railroad tracks in the background

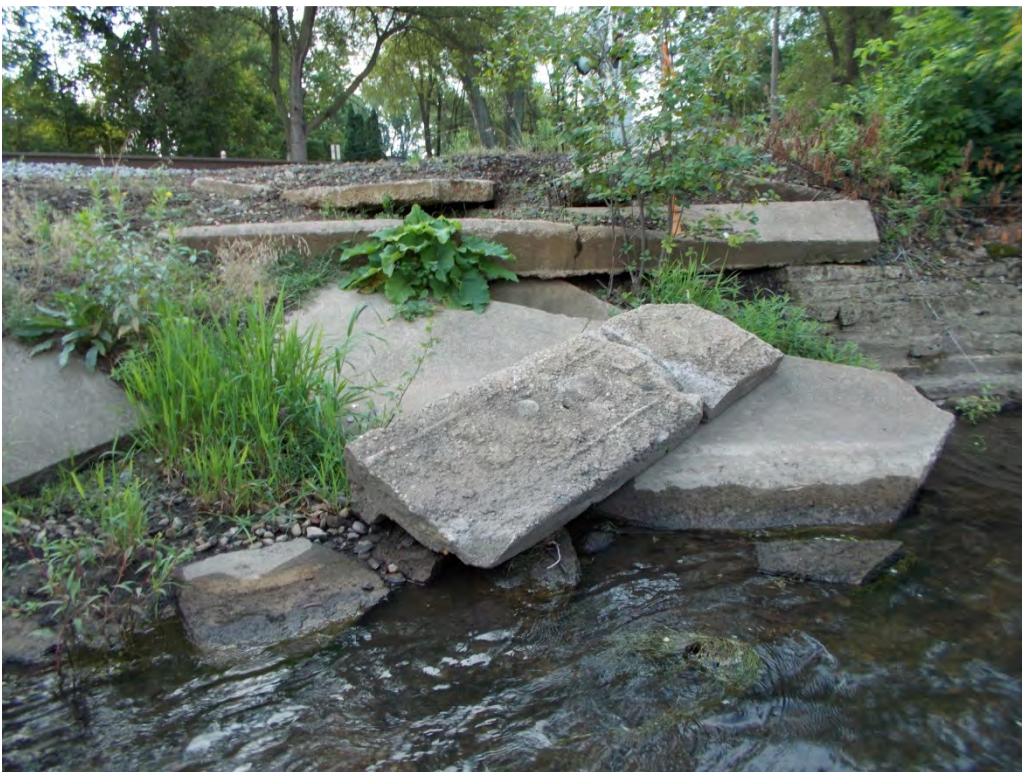
View of the slabs adjacent to the northeast wingwall extension of the Stockbridge Bridge

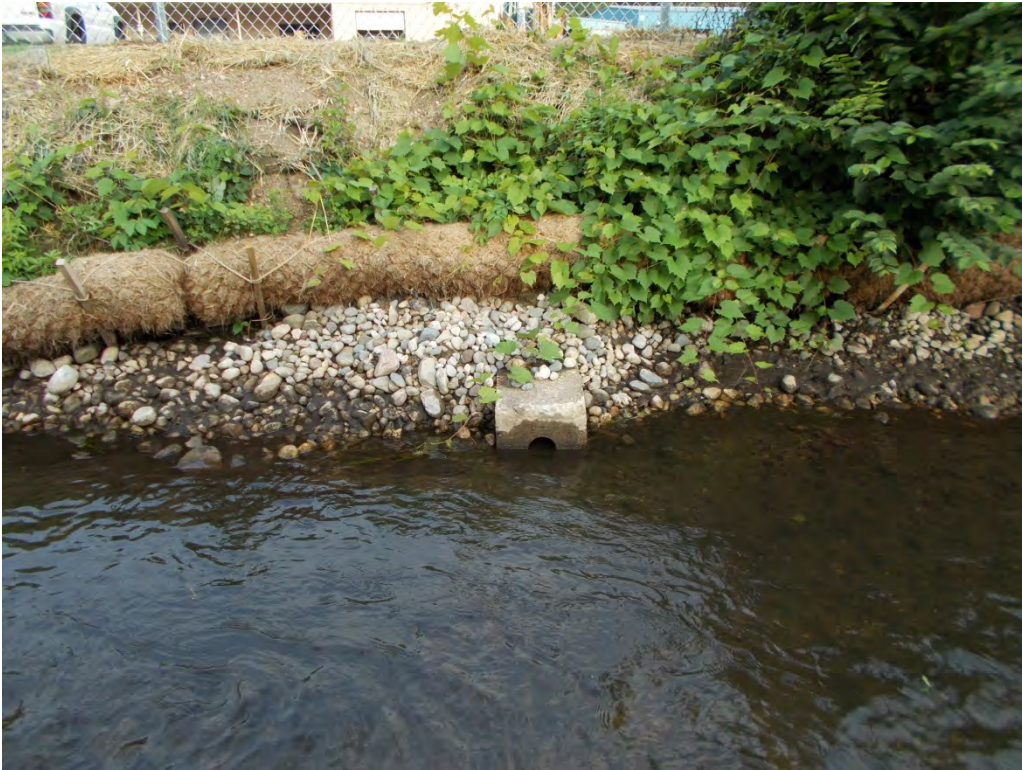
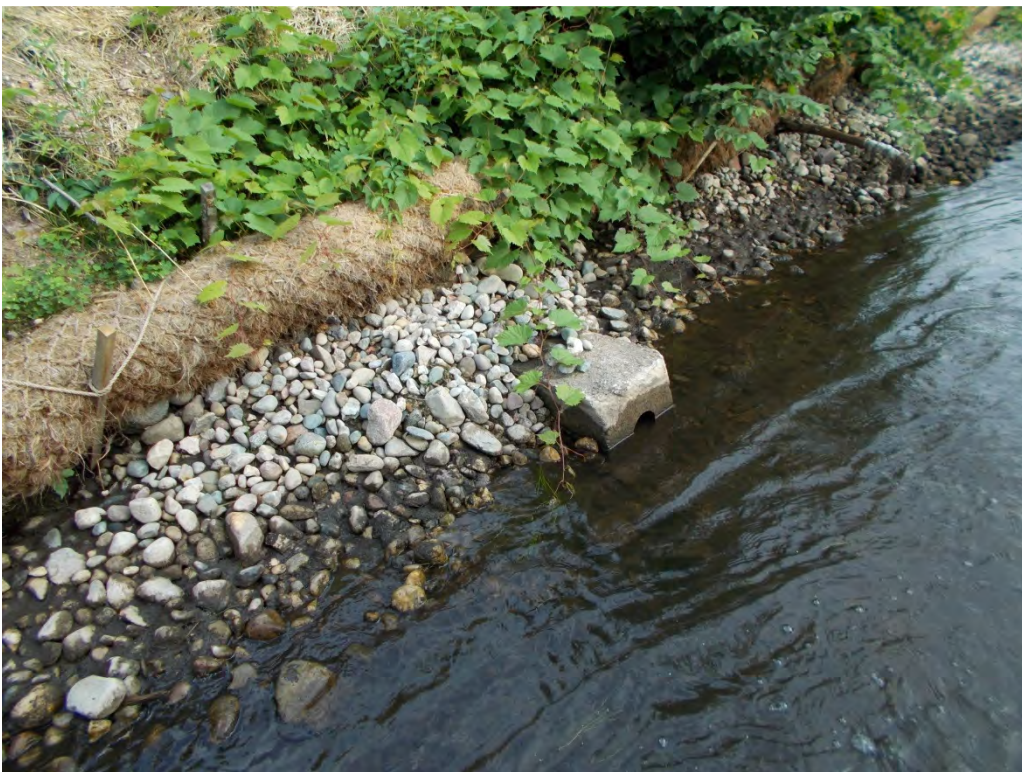
- The bank area around the structure has been restored with stone riprap.
- The structure does not appear to have been impacted during sediment removal.

View of the structure from the channel

View of the structure from the upstream bank

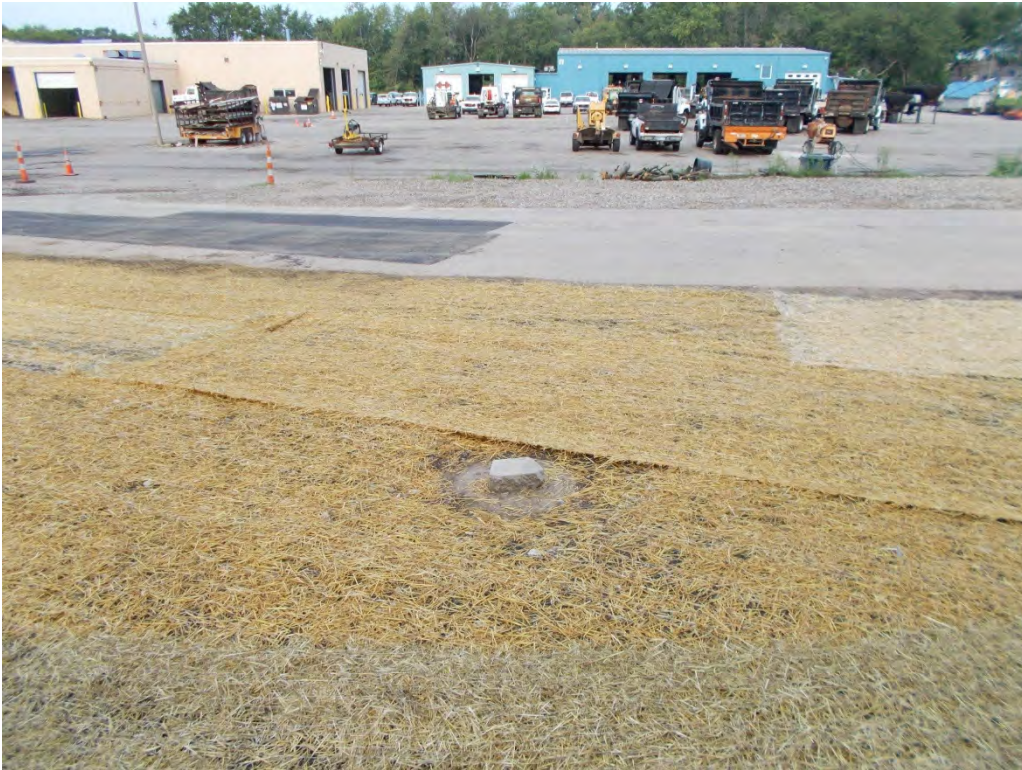
Manhole on the west side of the creek

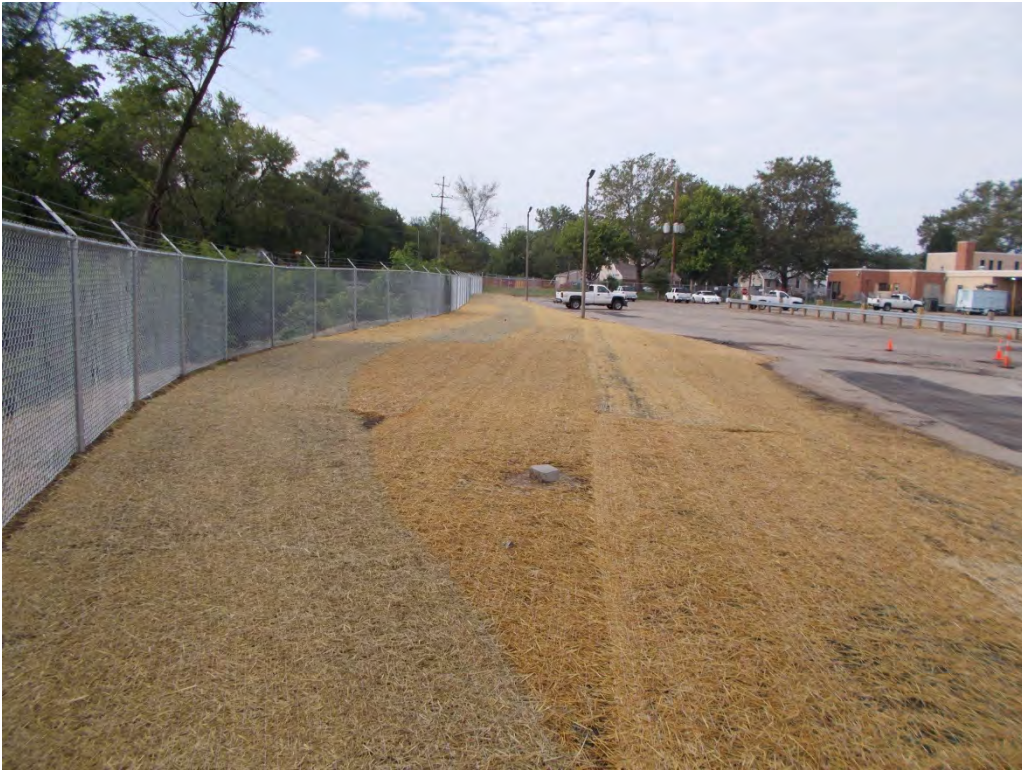
View of the west manhole looking south

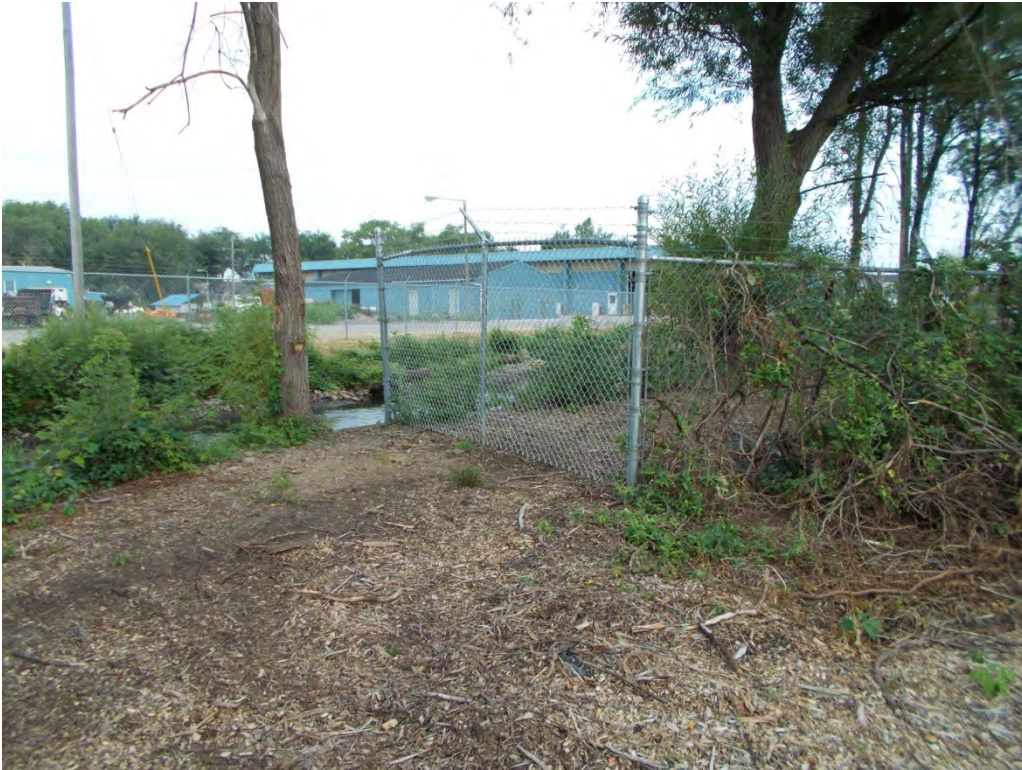
- The fencing has been removed and replaced, however, the end section into the channel was not yet installed at the time of assessment.

View of the fence from the southeast

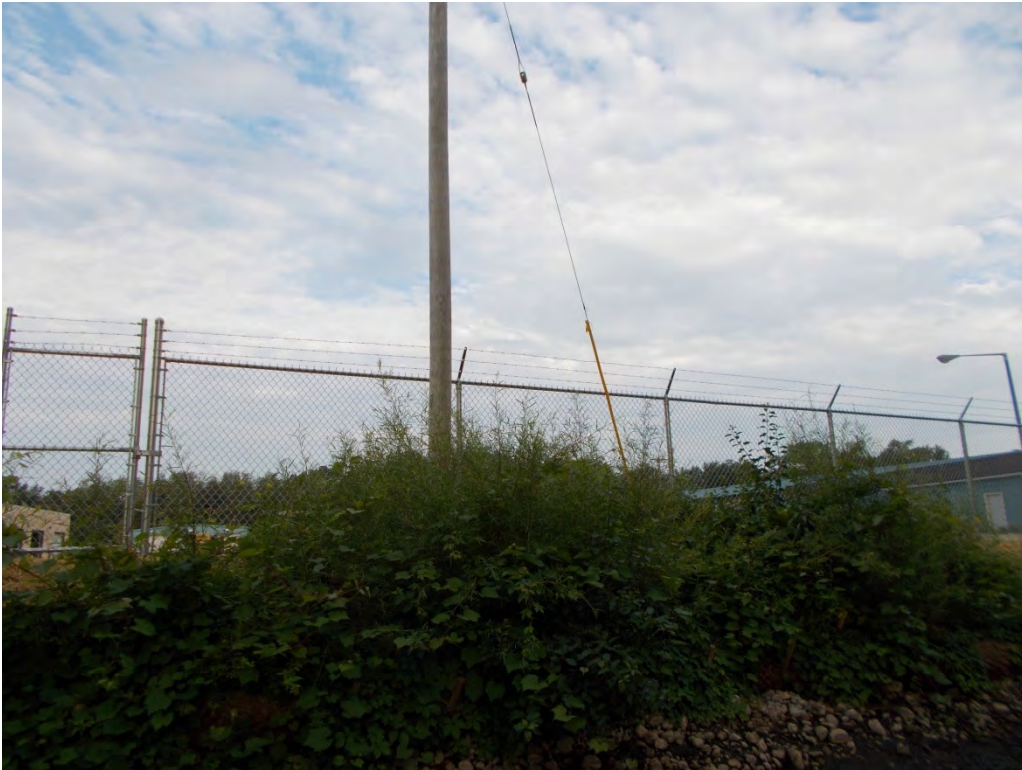
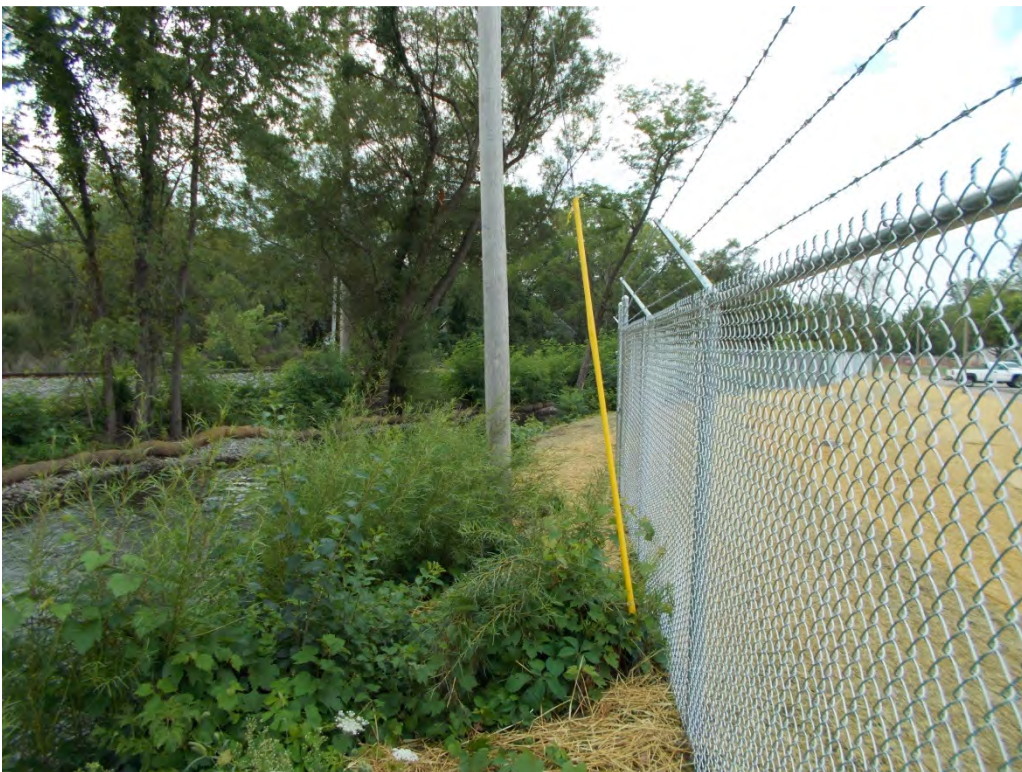
- The structure does not appear to have been impacted during sediment removal.

Pole and guy area viewed from the channel

View of pole and guy from the north

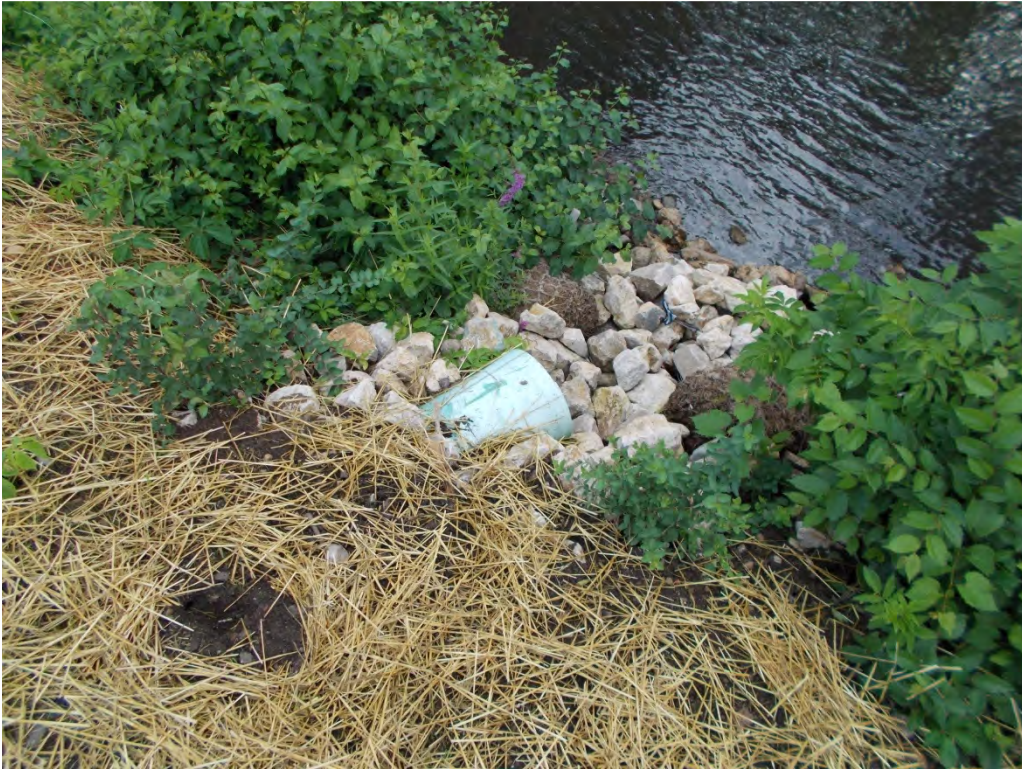
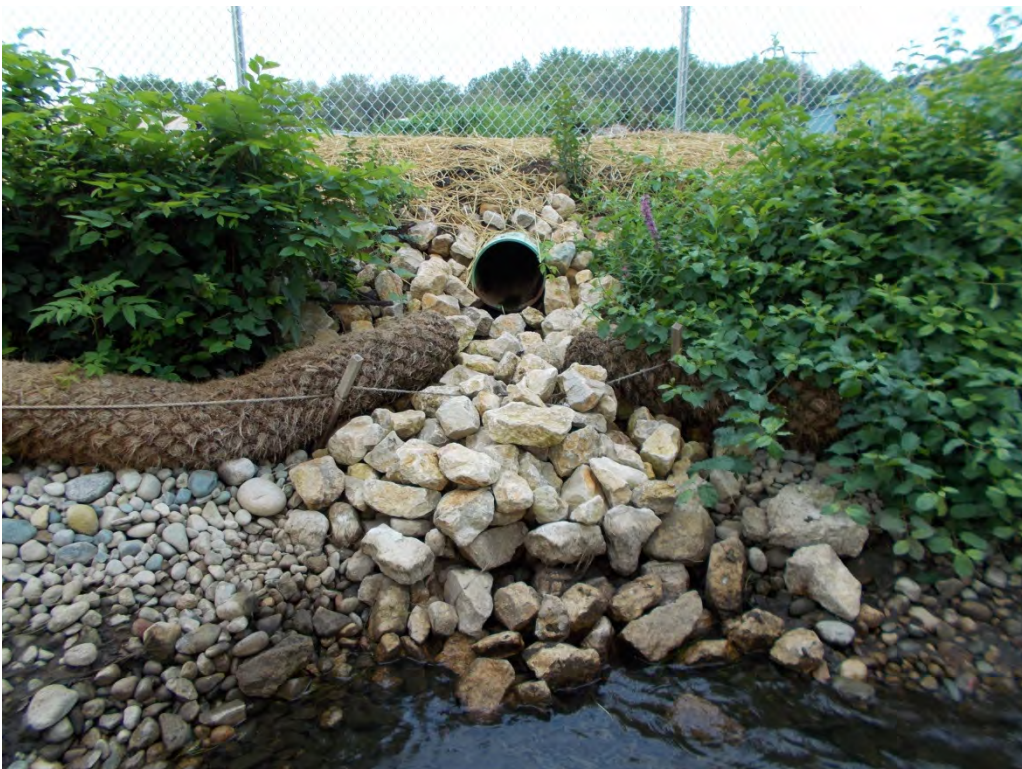
- Undermining of the outlet was improved during bank restoration.
- The failing concrete splash pad has been replaced with an improved riprap spillway.
- The capped PVC outlet has been removed.

View of the outlet from the top of bank

View of the outlet from the channel area

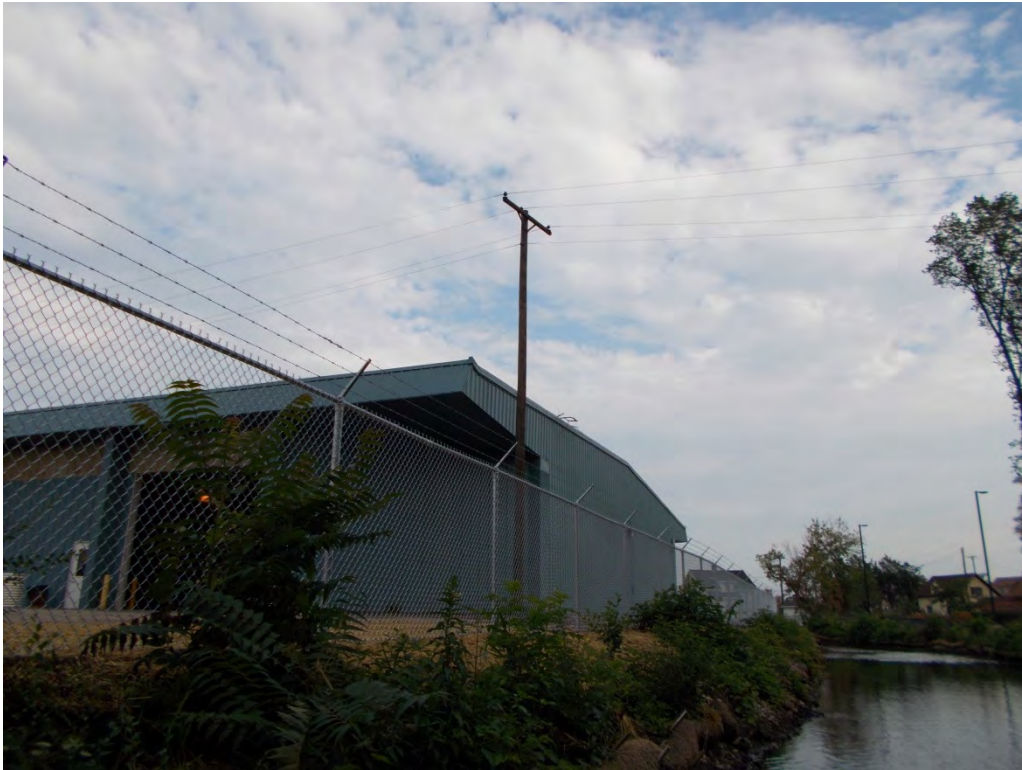
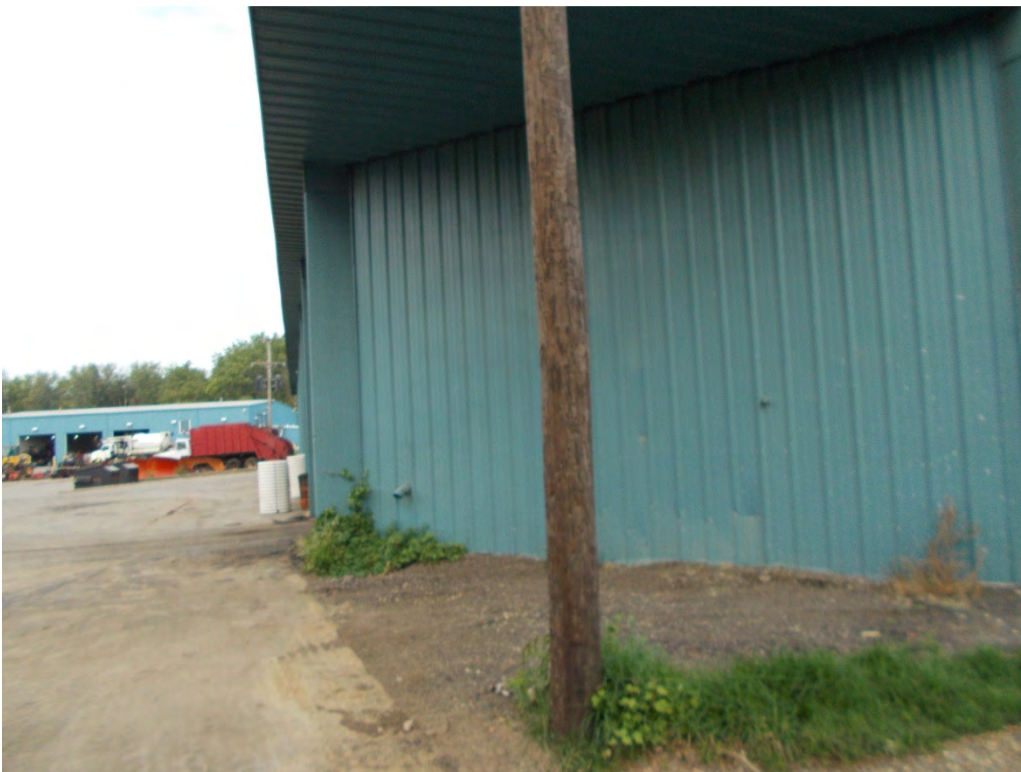
- The guy wire adjacent to the pole was eliminated in conjunction with sediment removal.
- The pole does not appear to have been impacted during sediment removal.

View of the pole from the downstream channel

View of the pole from the north

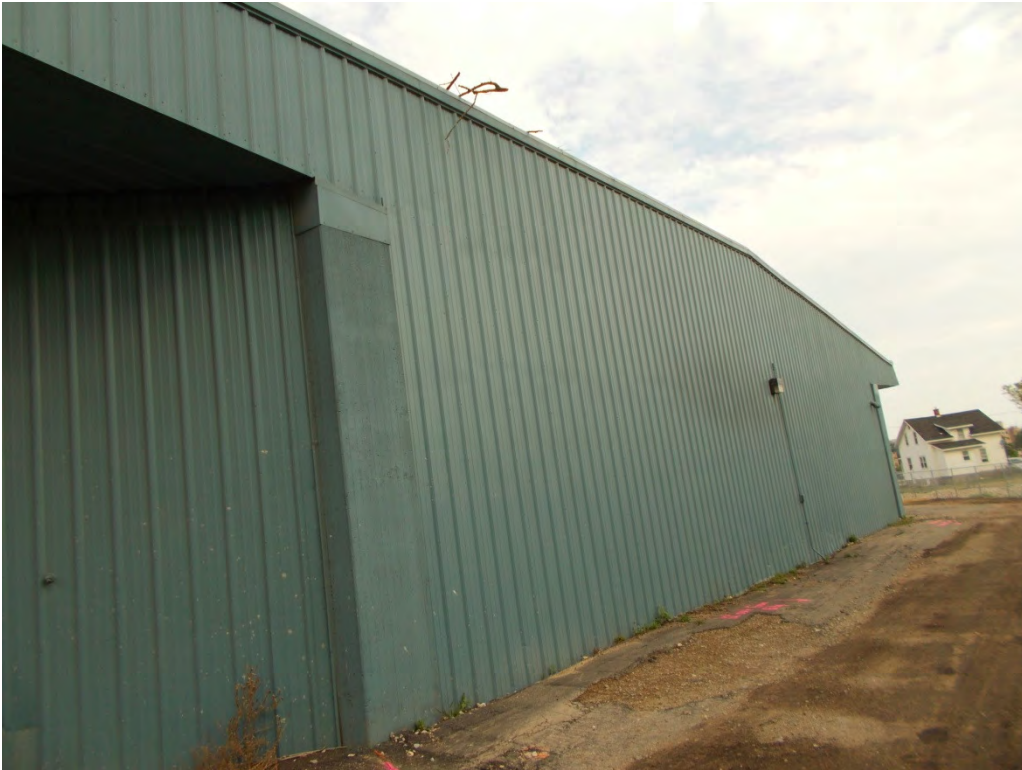
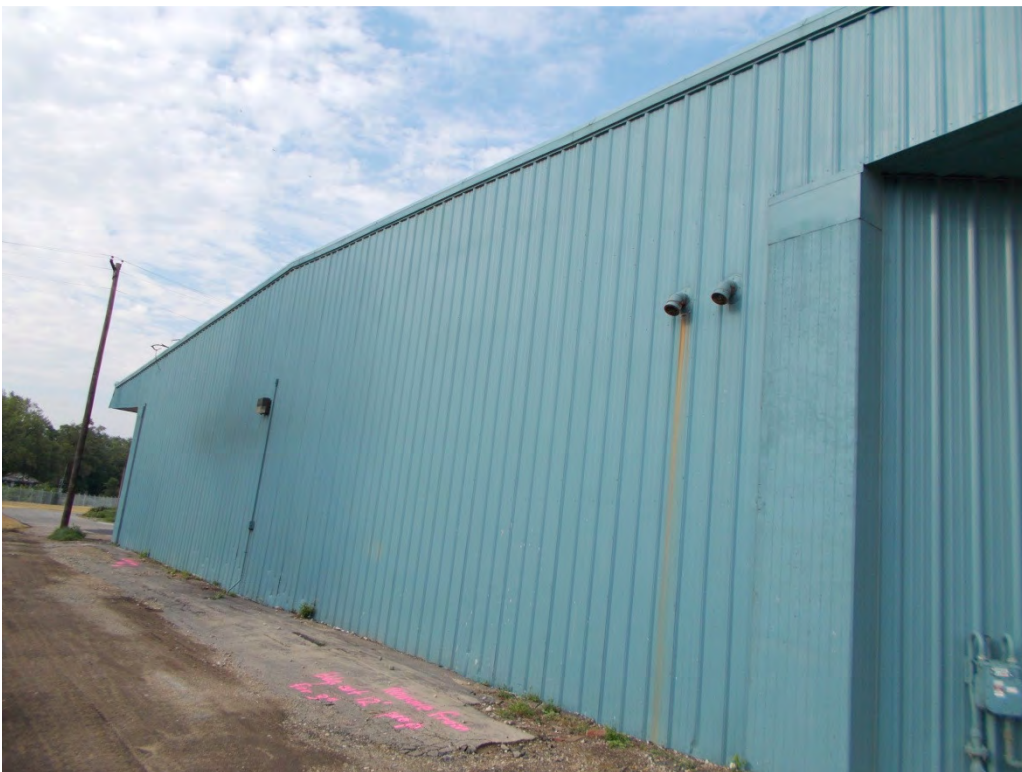
- The building does not appear to have been impacted during sediment removal.
- The asphalt access road appears to have been damaged during sediment removal. We understand that it is being replaced to the limits marked in paint.

View of building looking north

View of building looking south

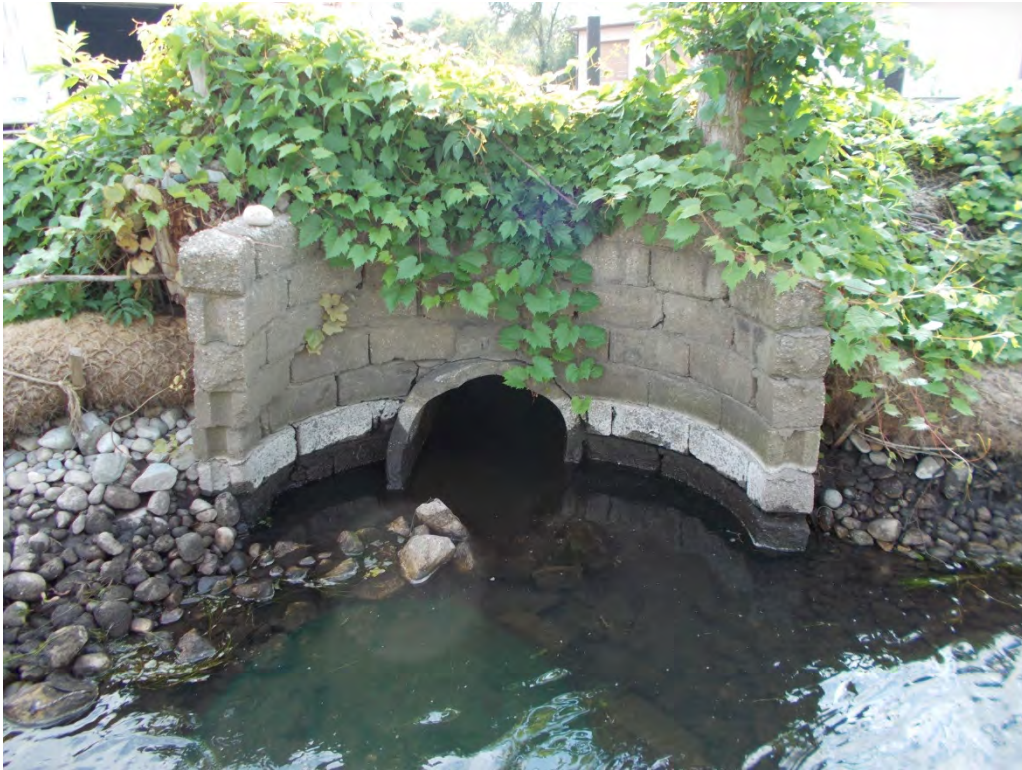
- It appears that the retaining wall blocks have been removed from the top of the headwall, however, they were not functional prior to sediment removal.
- The headwall itself and outlet do not appear to have been impacted during sediment removal.

View of the structure from the channel

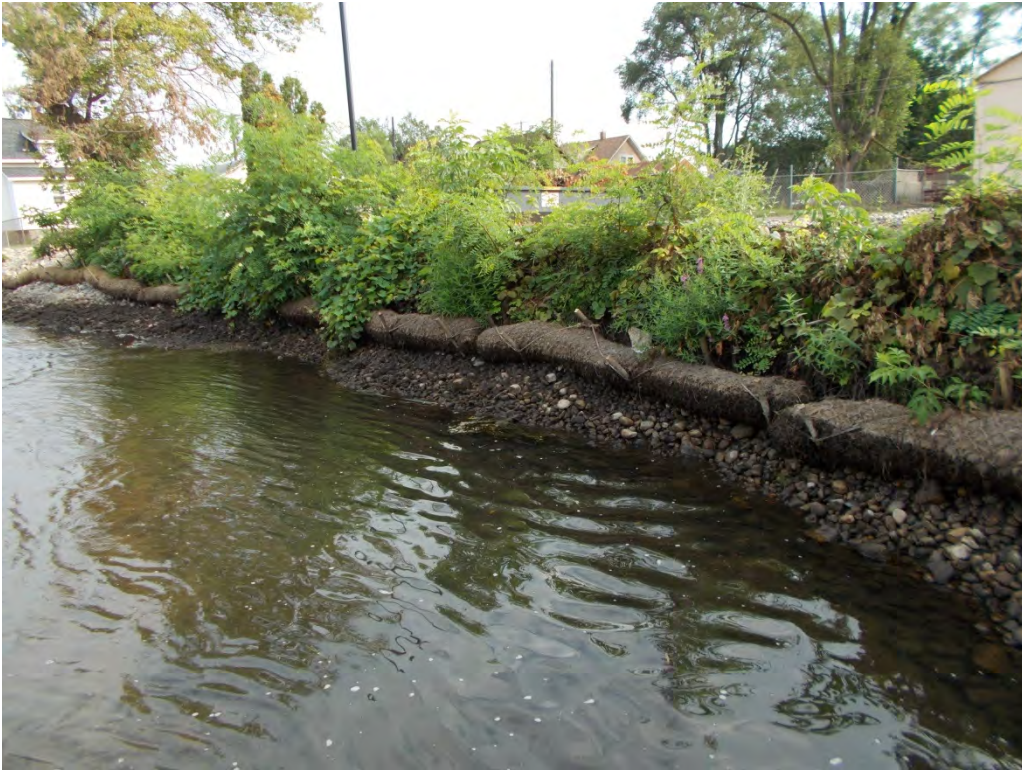
- Structure SA6-S17 was removed during sediment removal.

Bank restoration in area SA6-S17 was located

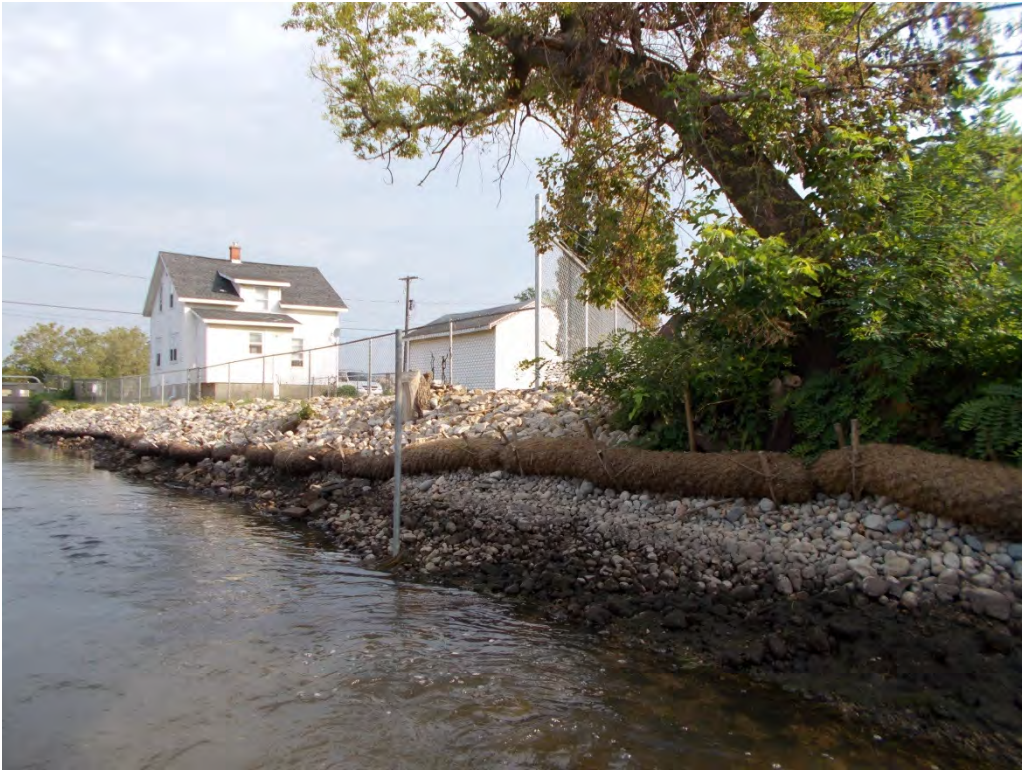
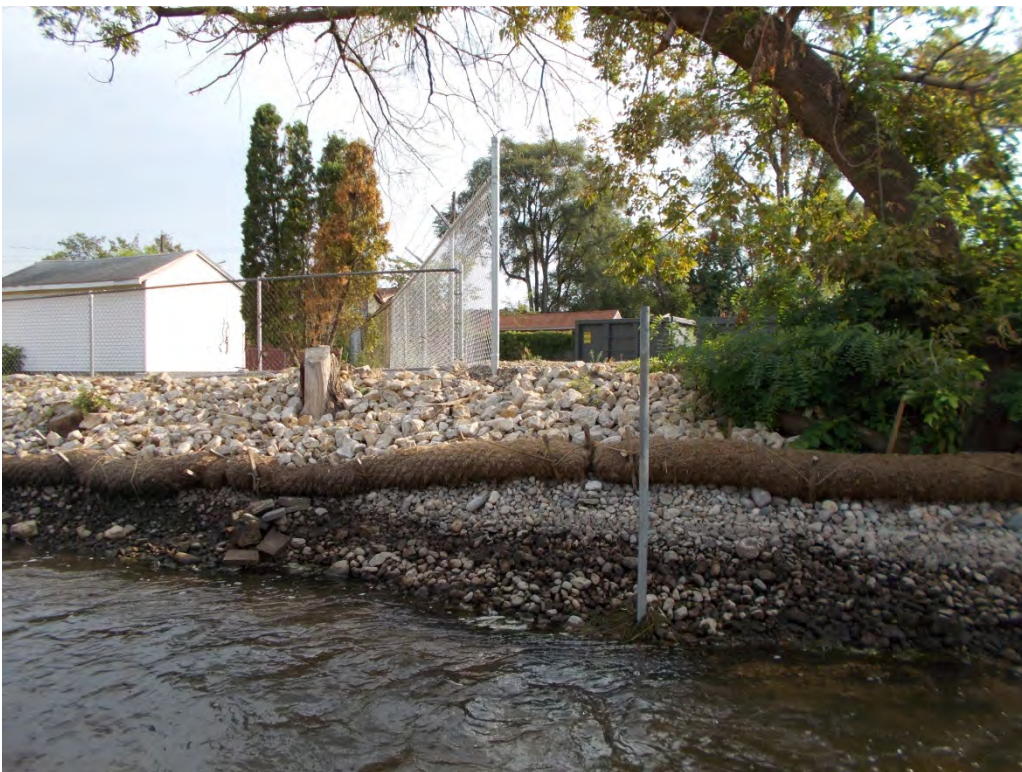
- The fence has been removed and replaced, however, the last section had not yet been installed at the time of assessment.

View of the fence from the upstream channel

View of the fence from the channel

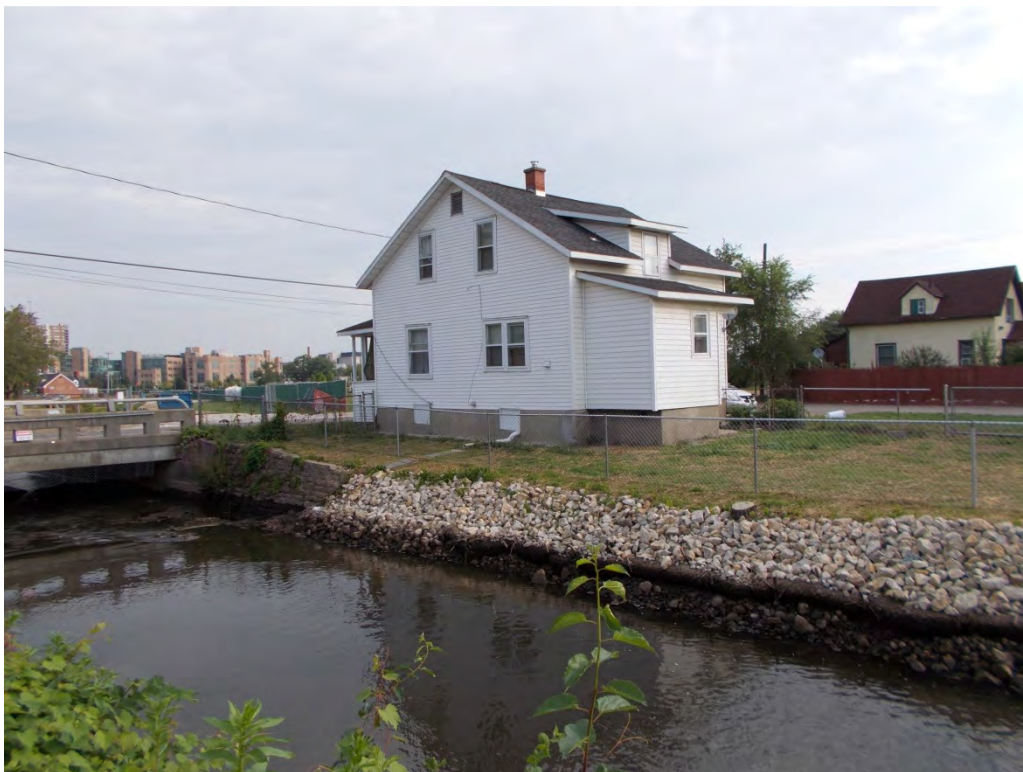
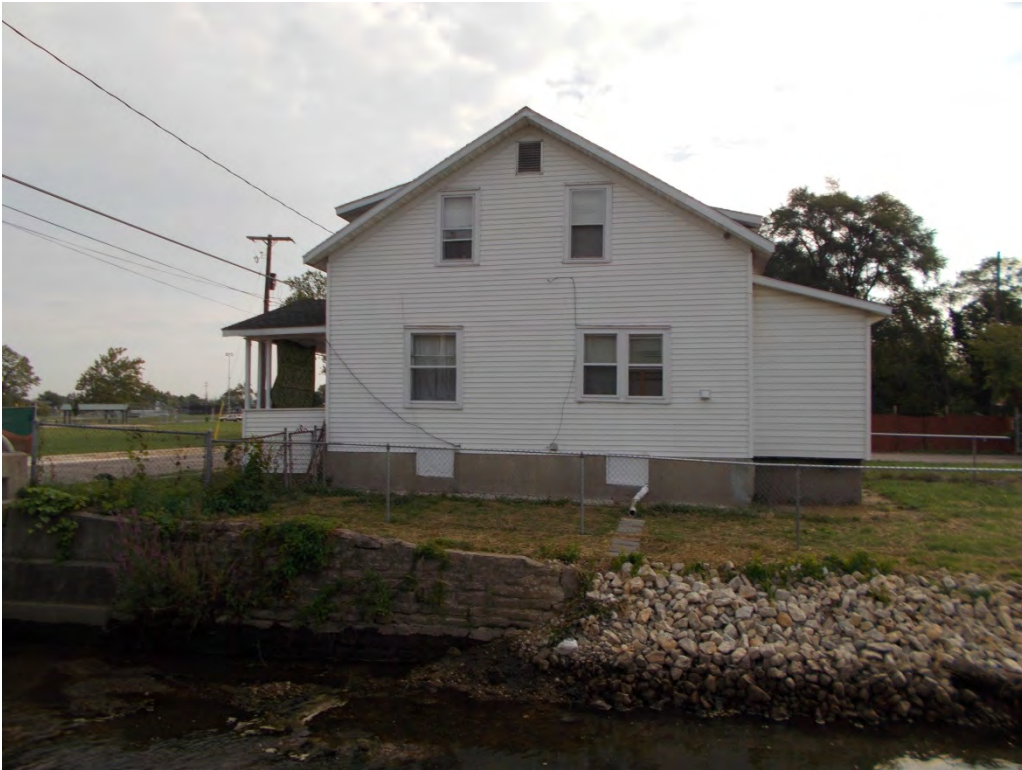
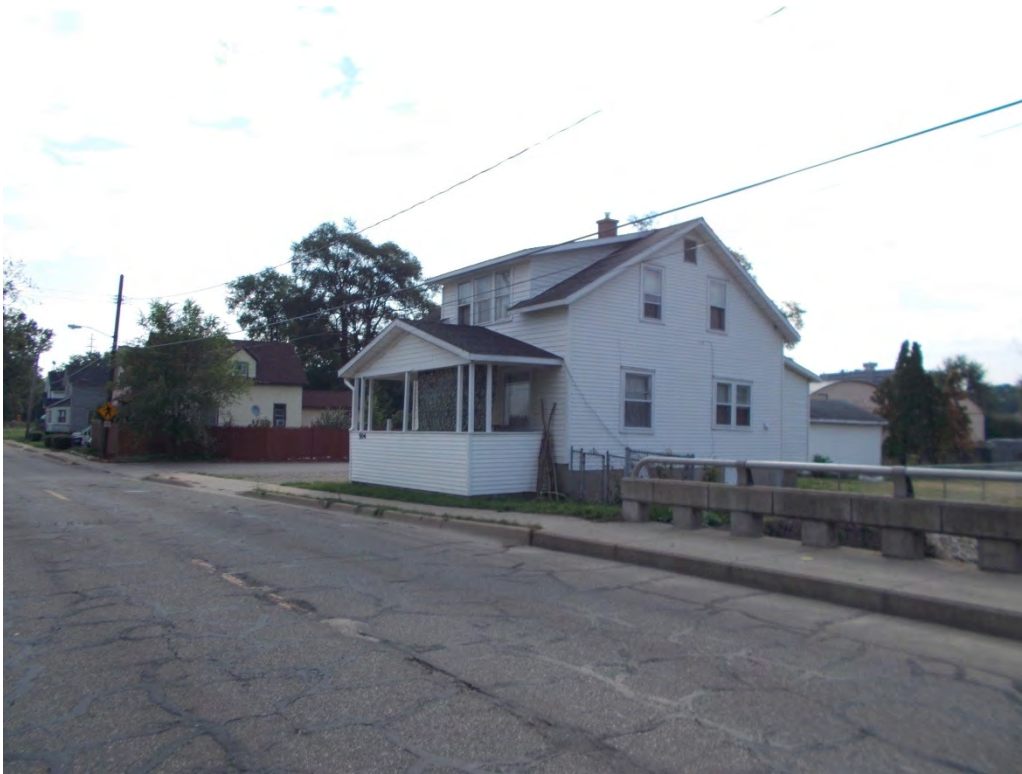
- The fence between the structure and channel has been replaced.
- The bank along the structure has been restored.
- Cracking in the foundation appears to be similar in nature to that observed prior to sediment removal.

View of structure from west bank

View of structure from channel

View of structure from northwest

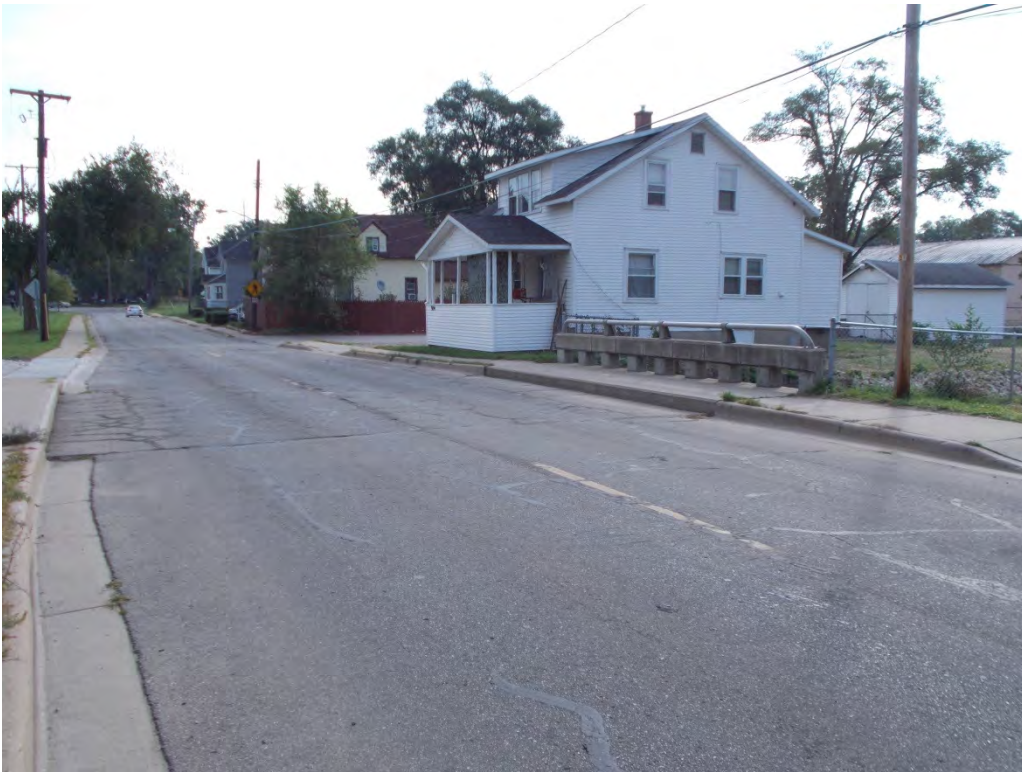
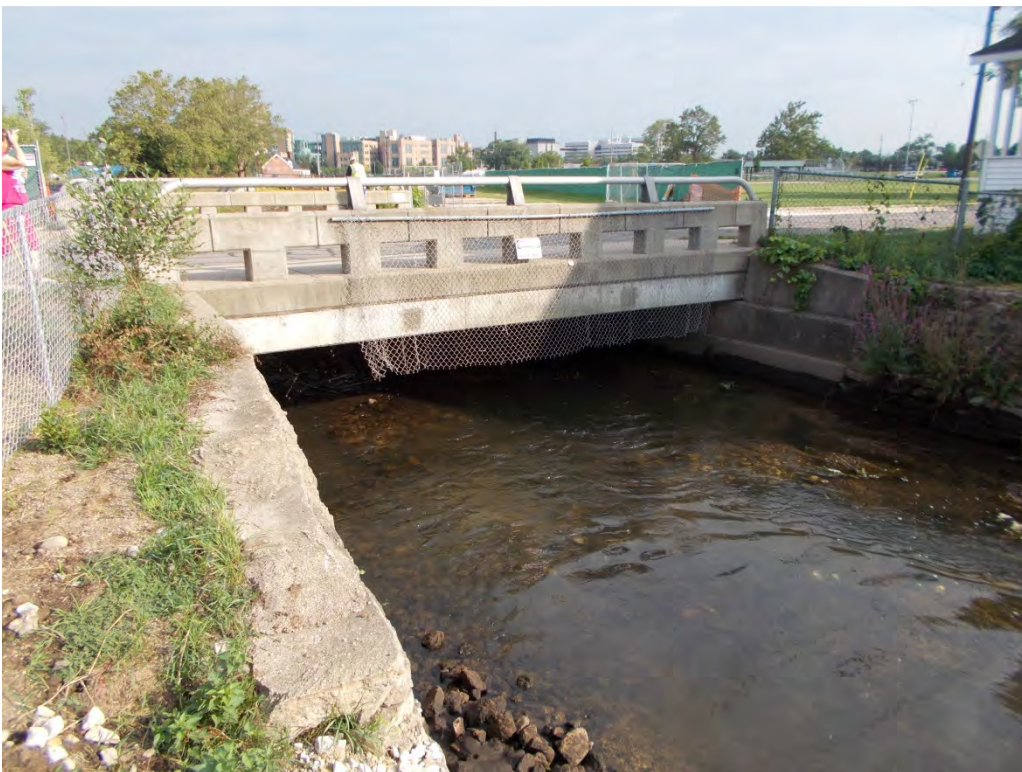
- Sediment removal operations were ongoing in SA5-D during the assessment. A final assessment of the structure will be completed with the assessment for SA5-D.
- The area around the block walls in the southeast and southwest has been restored.
- Fencing was replaced in the southwest.
- Temporary protective fencing has been installed on the south fascia.
- The structure does not appear to have been adversely impacted during sediment removal in SA6.

View of the structure from the northwest approach area

Elevation view of the structure from the southwest bank
